REPORT OF INVESTIGATION
(Underground Coal Mine)

NONFATAL COAL MINE OUTBURST (BOUNCE) ACCIDENT

Dutch Creek No. 2 Mine (ID No. 05-00469)
Mid-Continent Resources, Inc.
Redstone, Pitkin County, Colorado

June 5, 1980

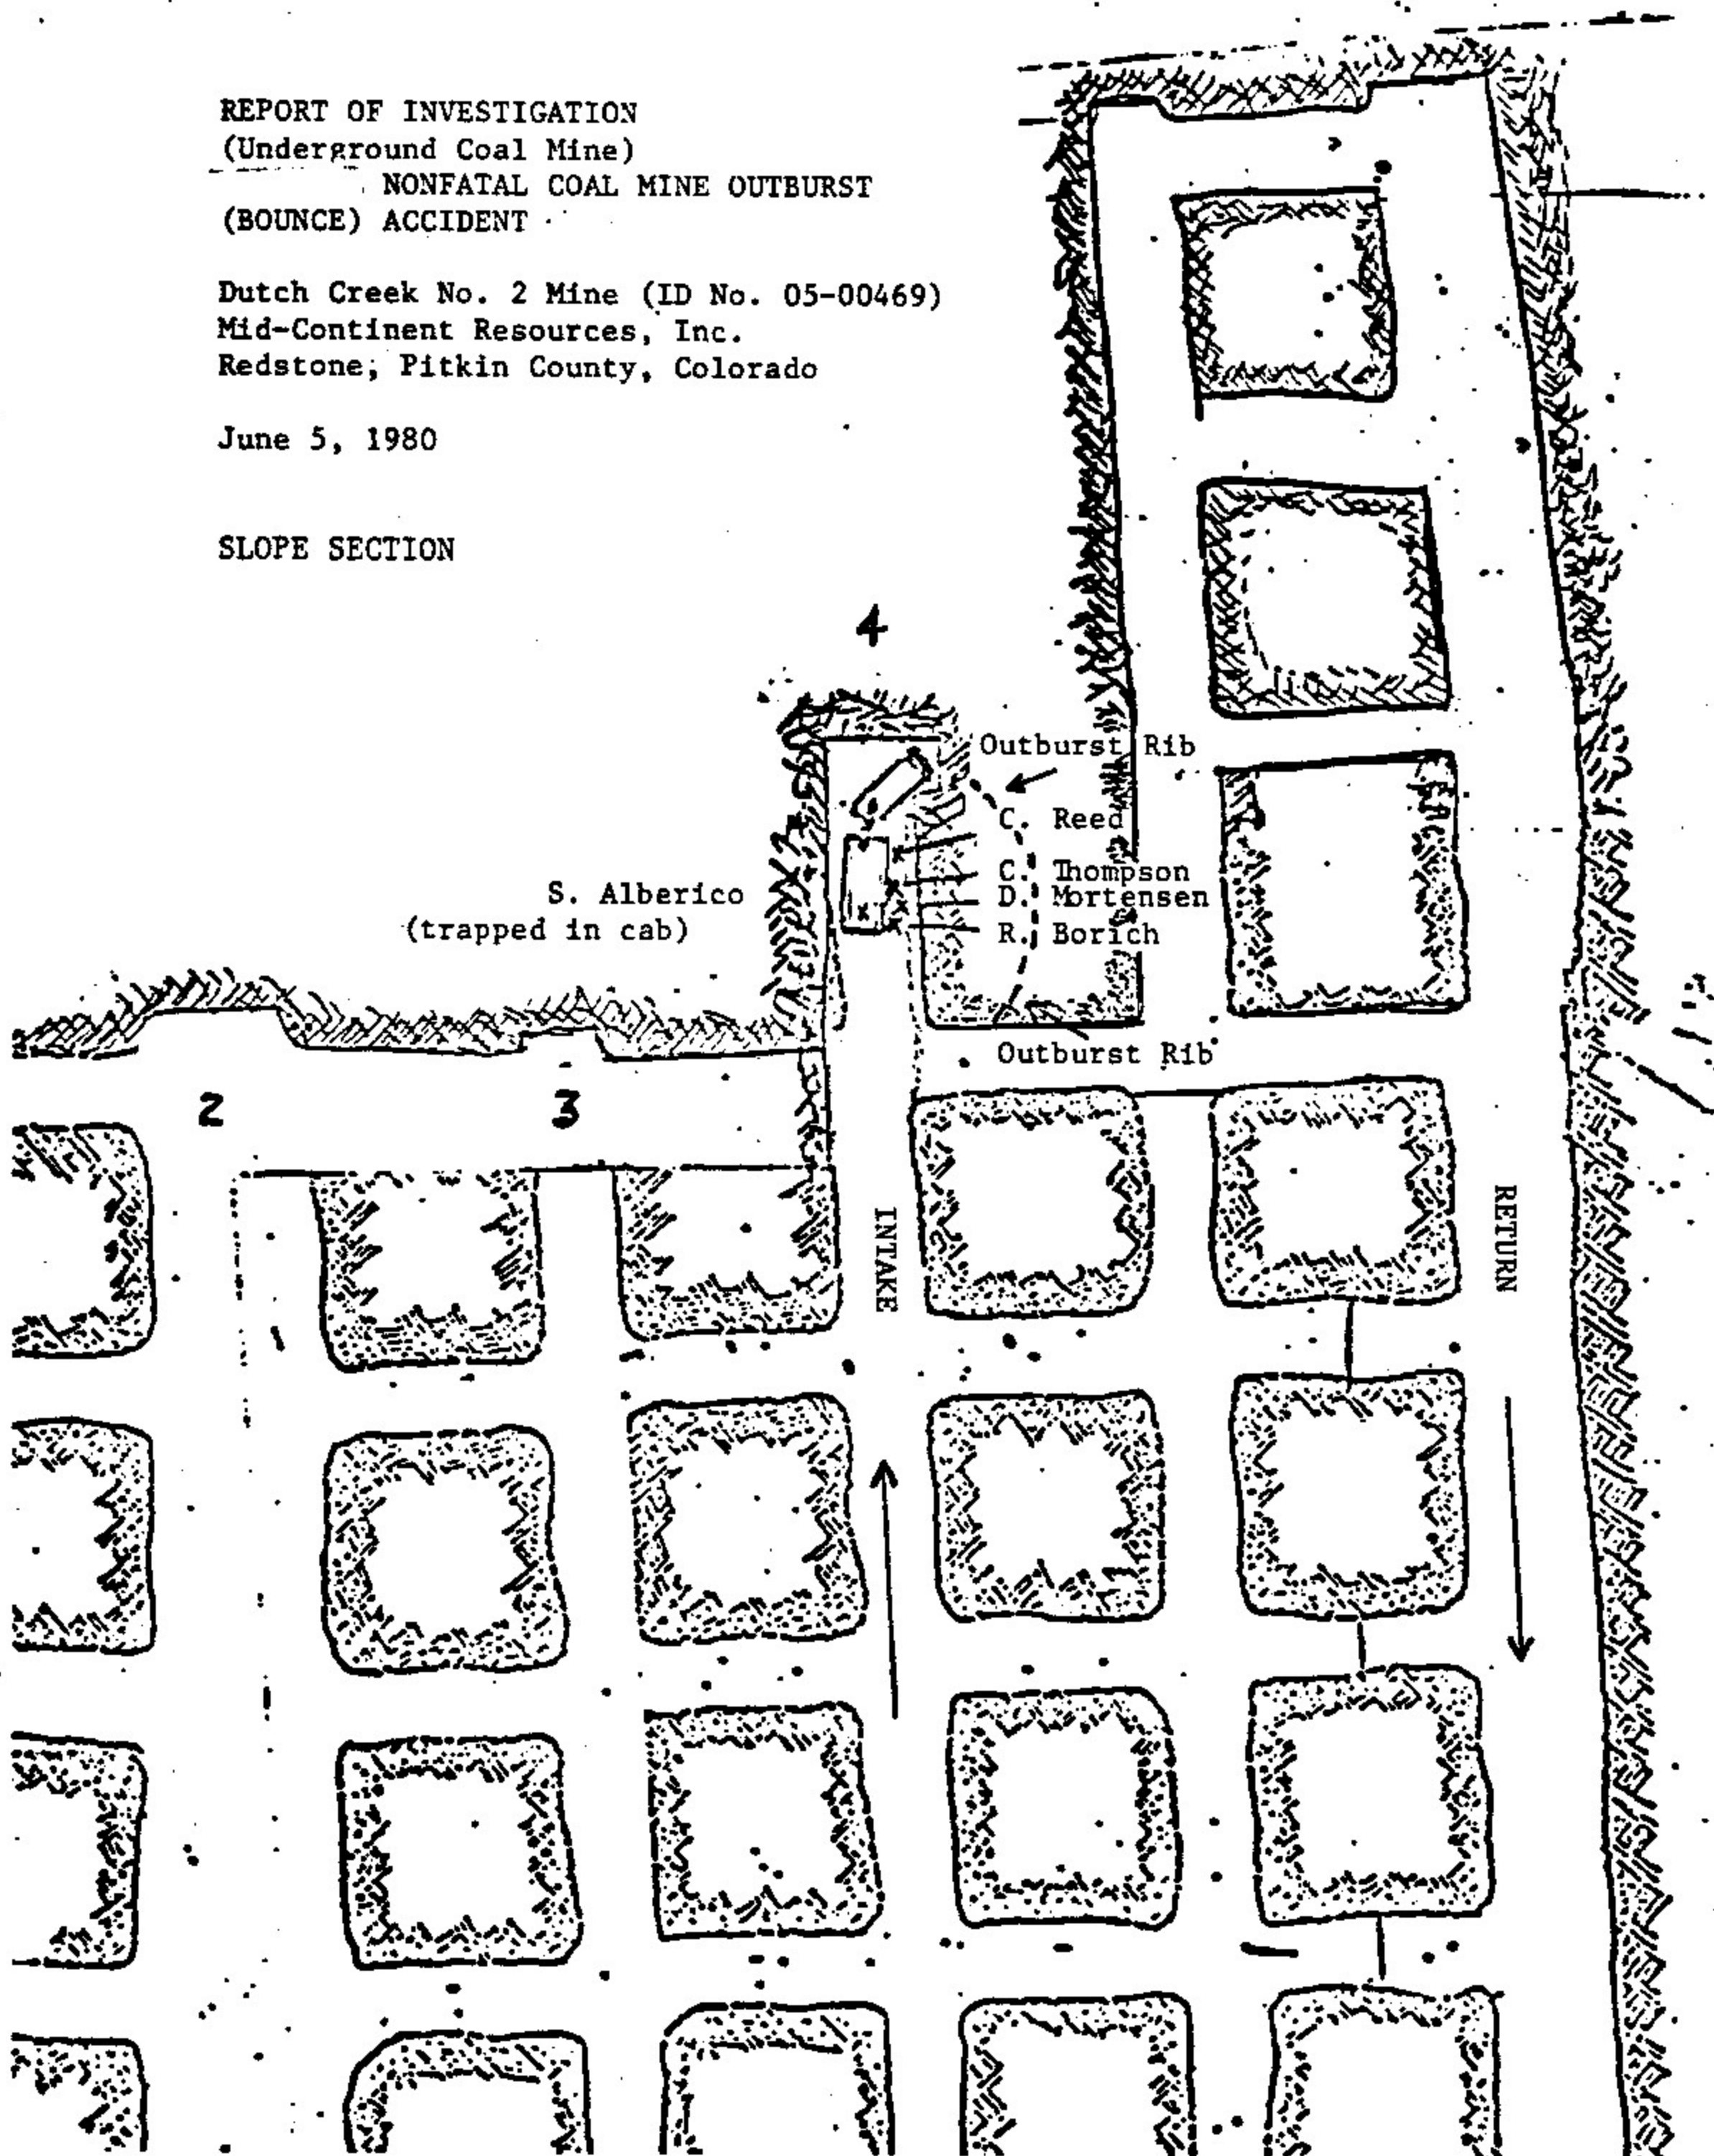
SLOPE SECTION

On Thursday, June 5, 1980, about 1:30 p.m., an outburst of coal (bounce) occurred in the No. 4 slope right rib from a crosscut being driven to the last open crosscut outby. Four miners were injured. The accident occurred because of the pressure on the pillar from the mining method.

1. The length of the outburst was from the last open crosscut to the crosscut being mined.
2. The outburst of coal did affect ventilation.
3. The outburst of coal occurred in an area where No. 5 and No. 6 slopes were advanced 300 feet inby.
4. Four miners received personal injuries.
5. This seam of coal has considerable overburden in excess of 2,000 feet.
6. The coal being mined was not being relieved of stress by any means.

Probable cause of the outburst of coal (bounce) was mining of No. 5 and No. 6 slopes 300 feet in advance of the other slopes allowing a buildup of pressure in the pillar of coal between No. 4 and No. 5 slopes.
